Glitched on Earth by Humans: A Black-Box Security Evaluation of the SpaceX Starlink User Terminal

Lennert Wouters

COSIC

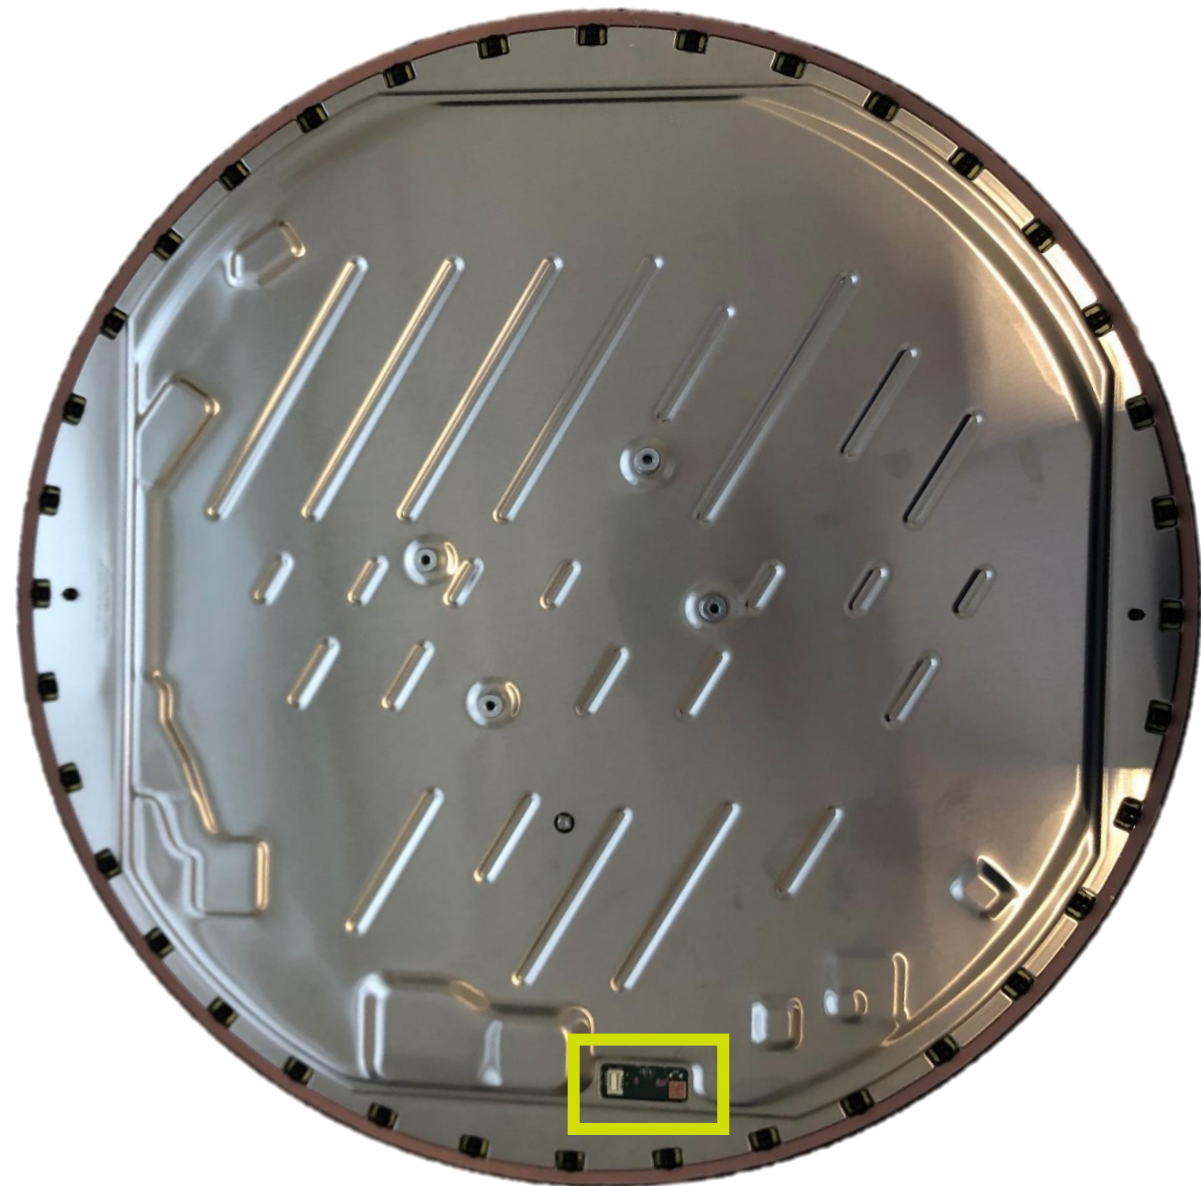
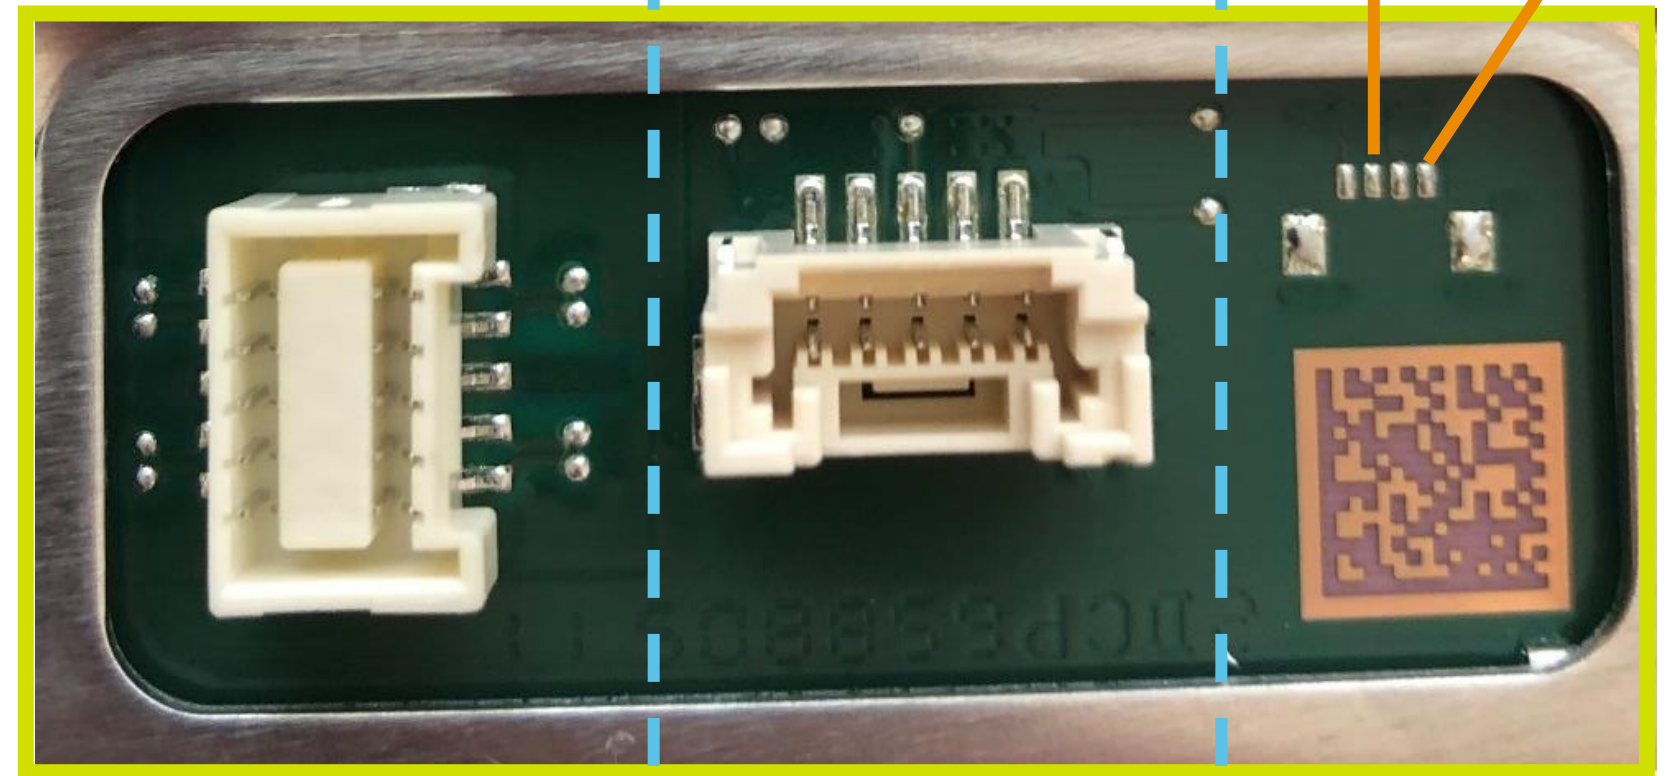
Accessible connectors on V2*

ethernet + power

JST BM10B-ZPDSS-TF(LF)(SN)

motors

JST BM05B-ZESS-TBT(LF)(SN)

UART

UT TX
UT RX

*V1 hardware had an extra connector, V3 does not have easily accessible connectors

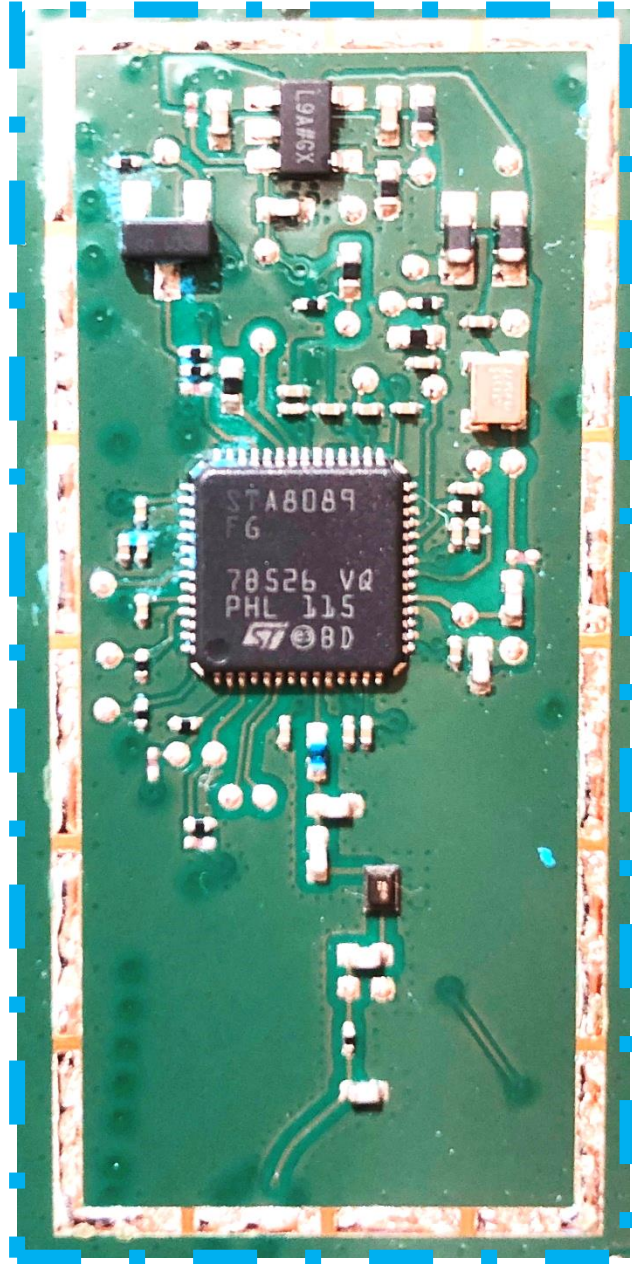
GPS receiver

STM STA8089

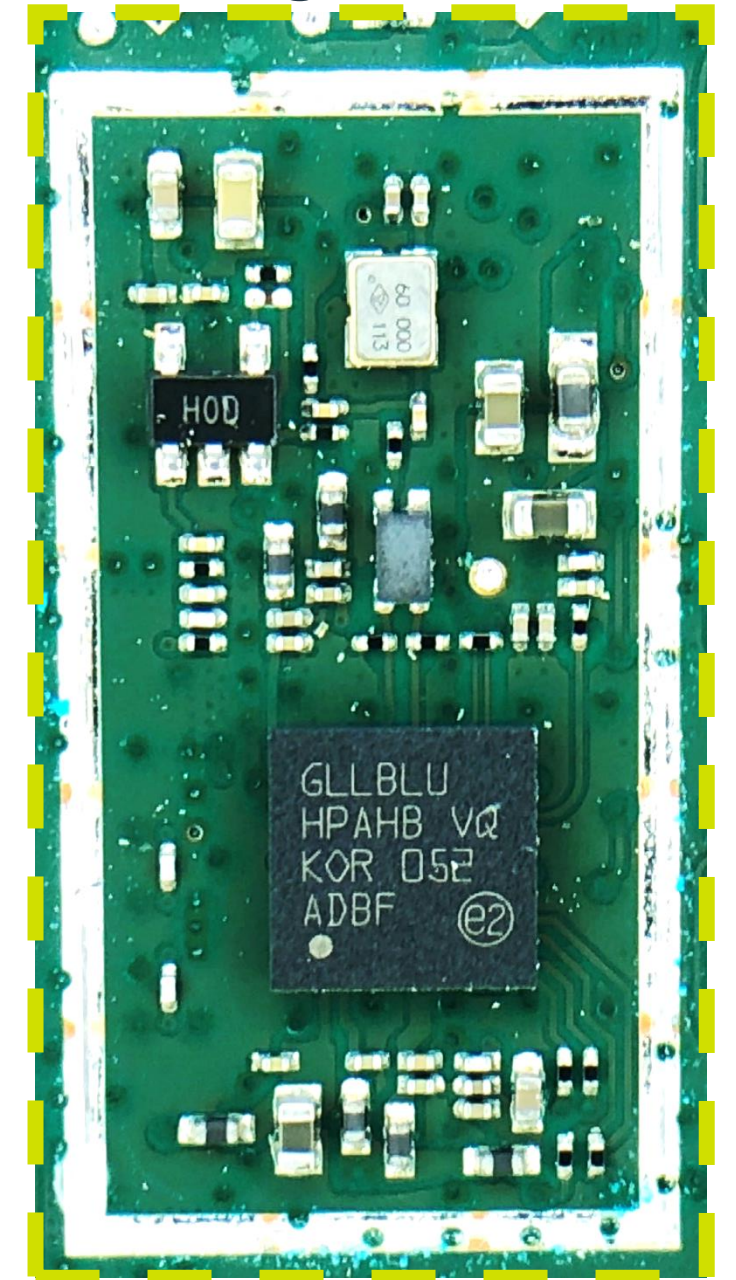
Clock generation

GLLBLU

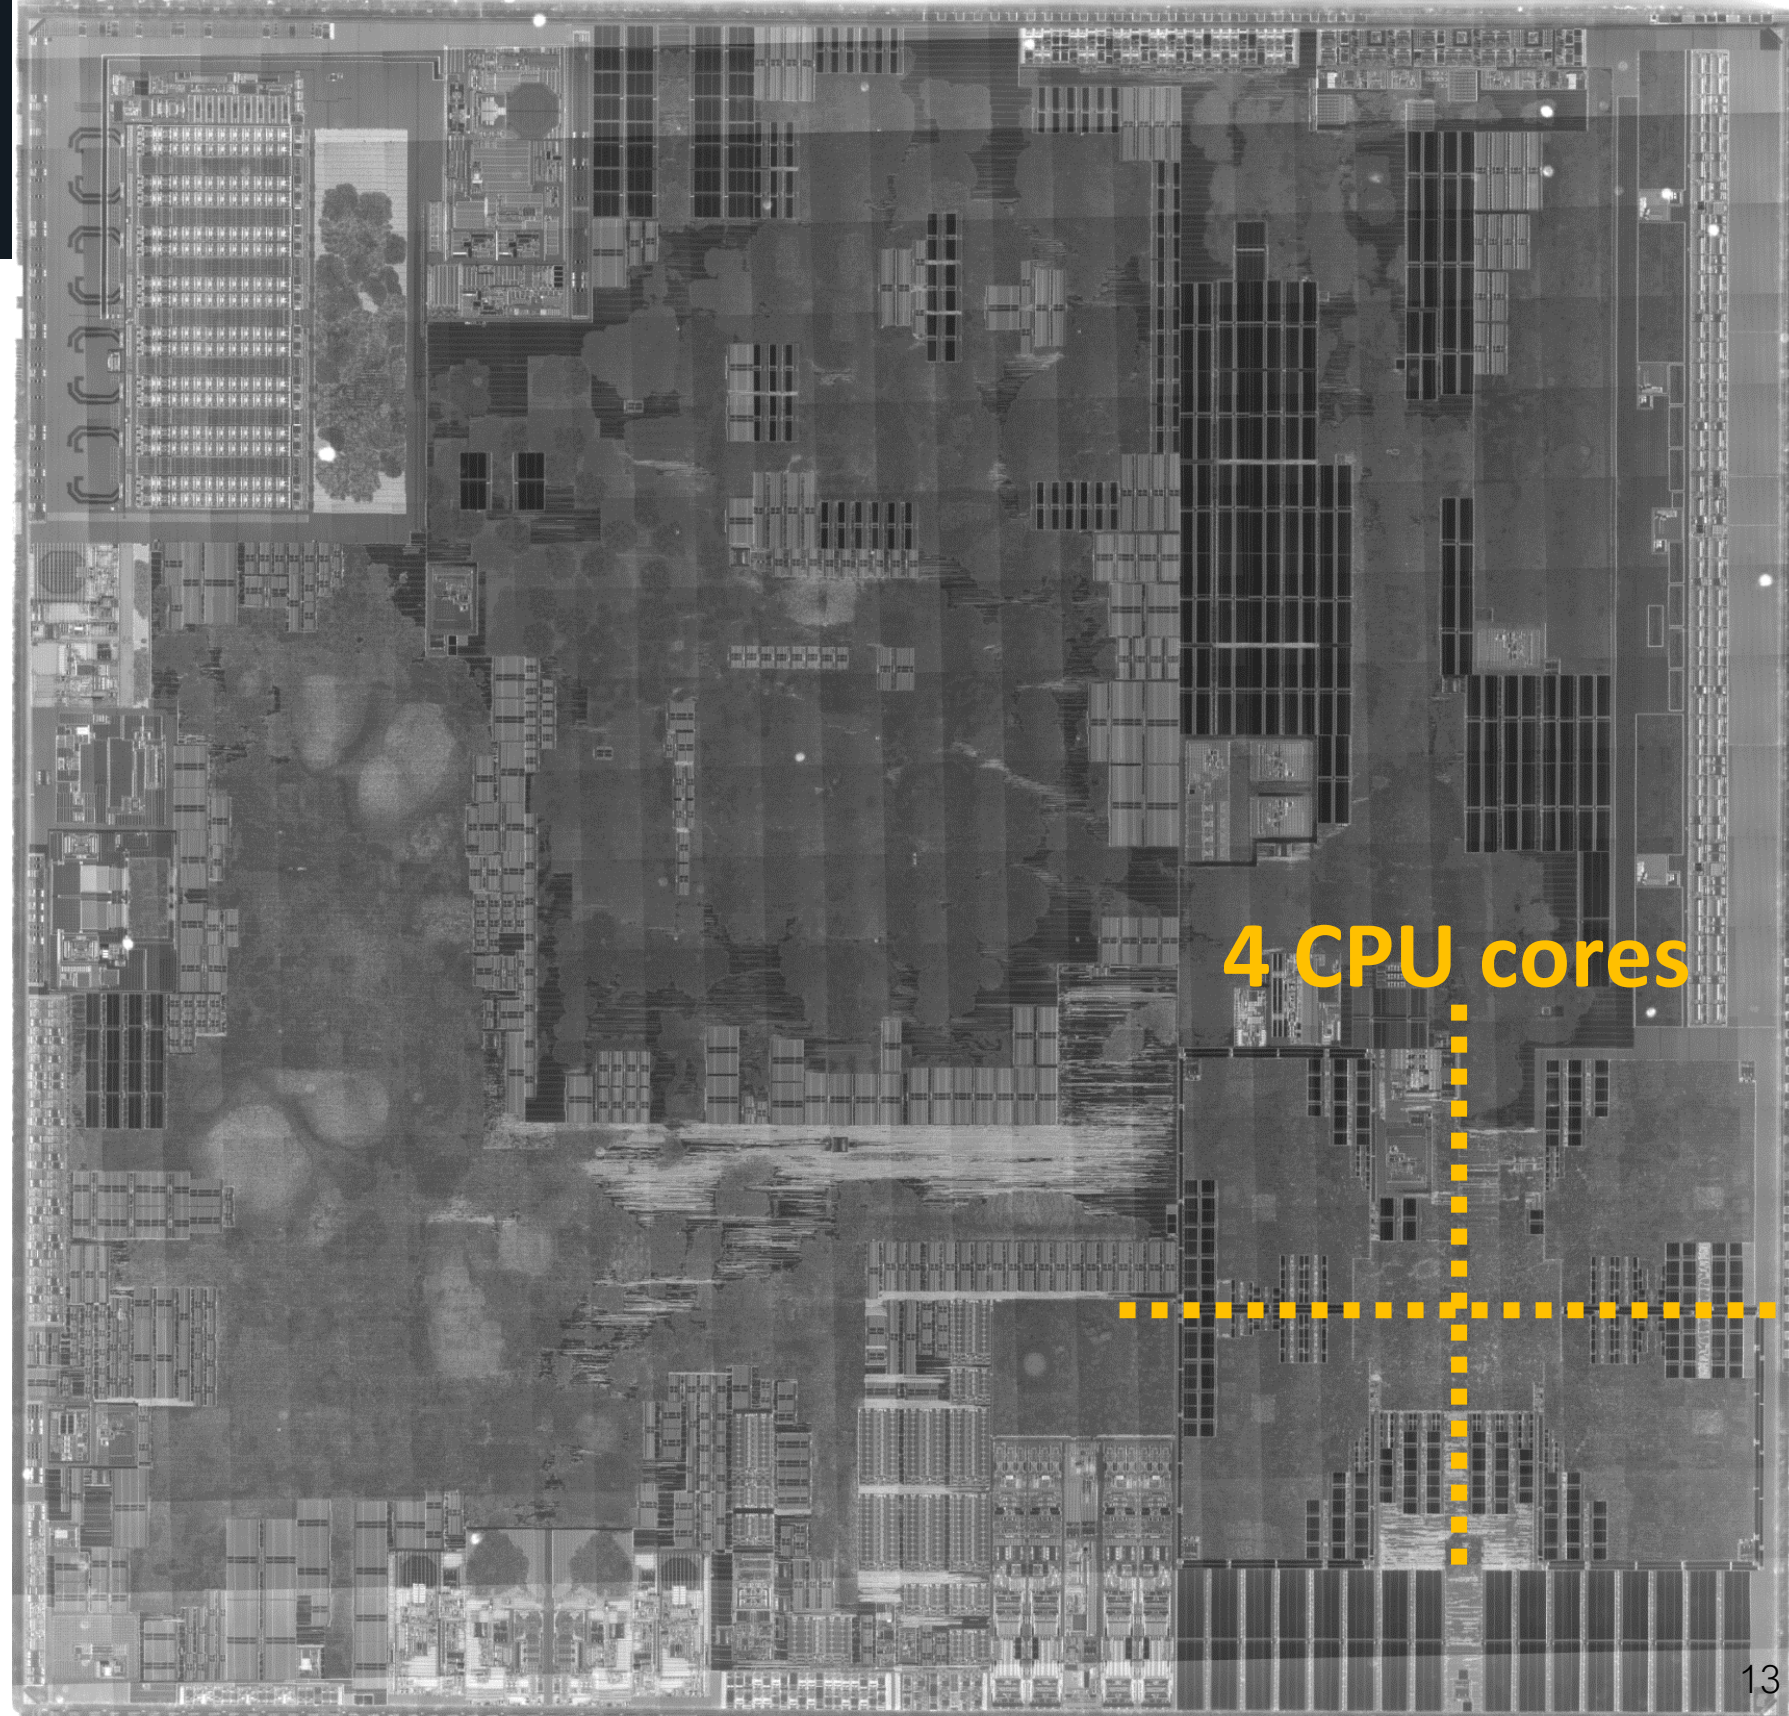
SoC

- through substrate image
 - GLLCCOCA6BF (cut 3?)
 - Thorlabs NIR camera
 - Mitutoyo NIR objective 50x
- Can help narrow down interesting locations for some physical attacks
- Full resolution version is available on siliconpr0n.org!

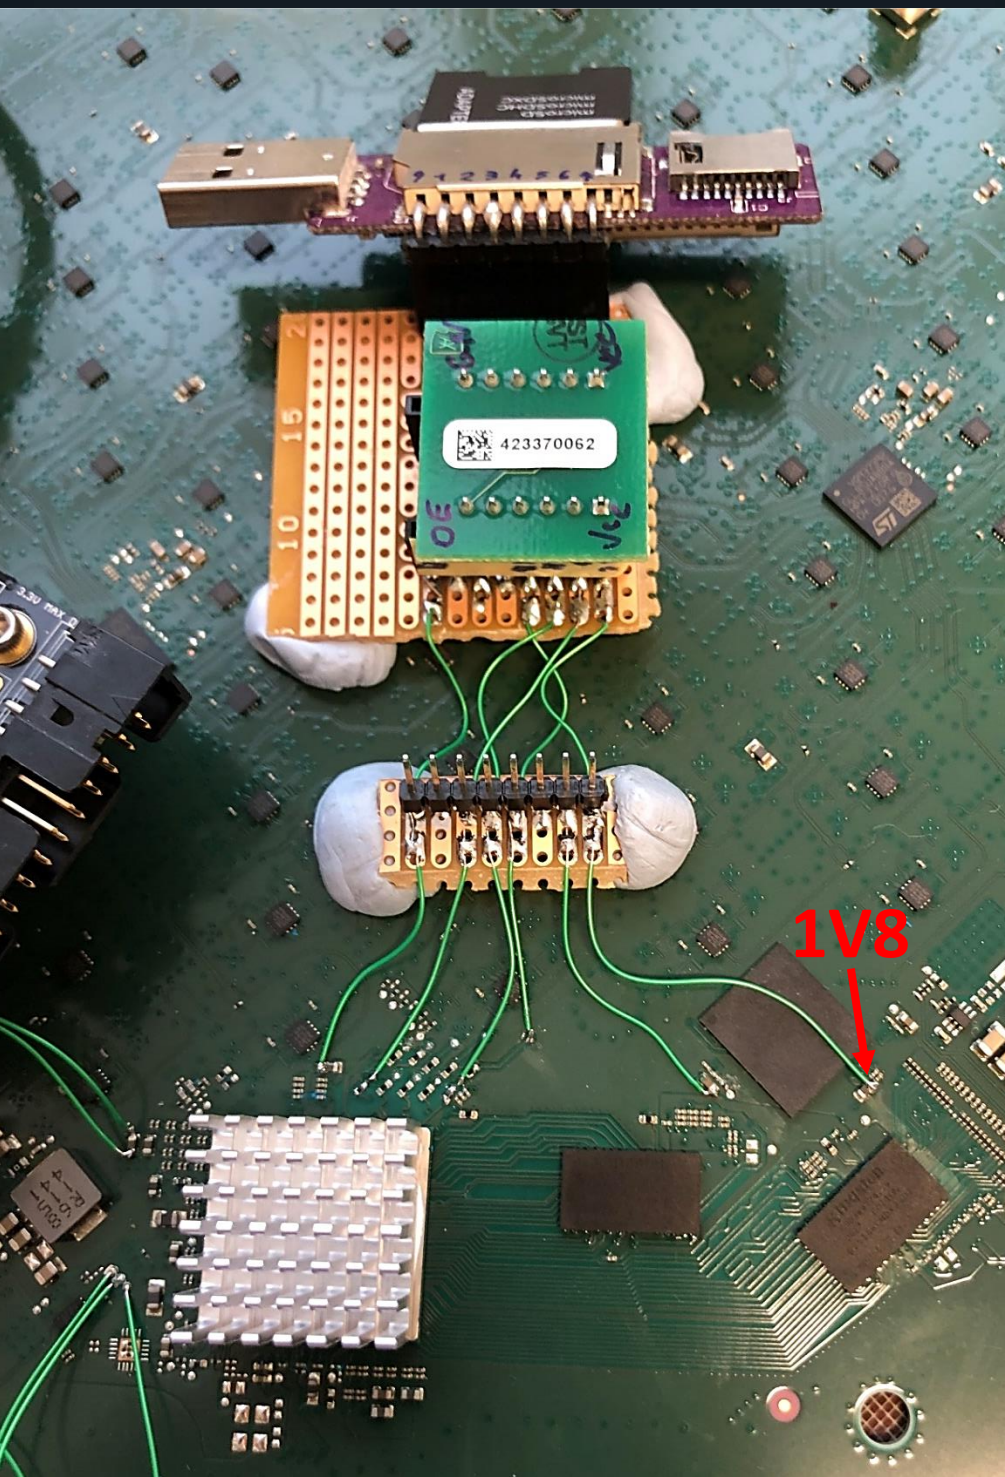
Reading eMMC in-circuit

SD card reader

TXS0202EVM
Level shifter

← What I did

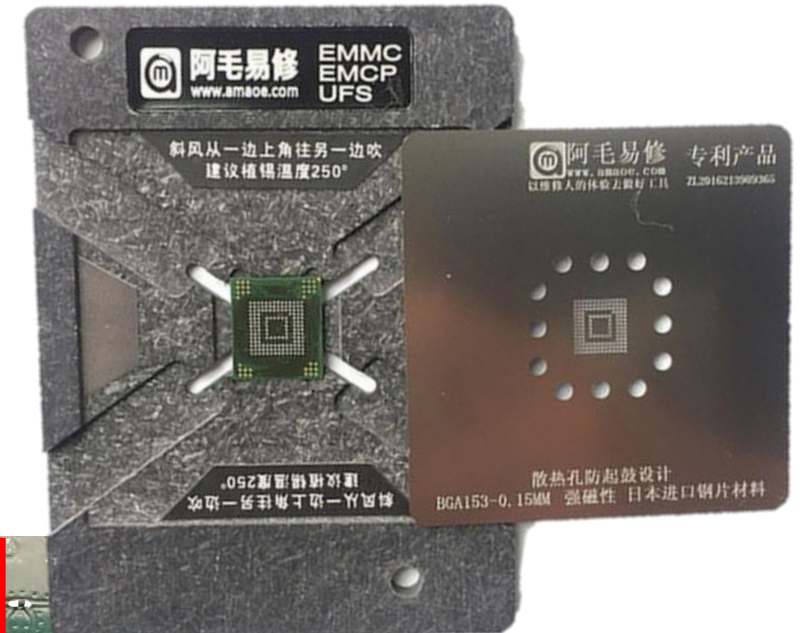
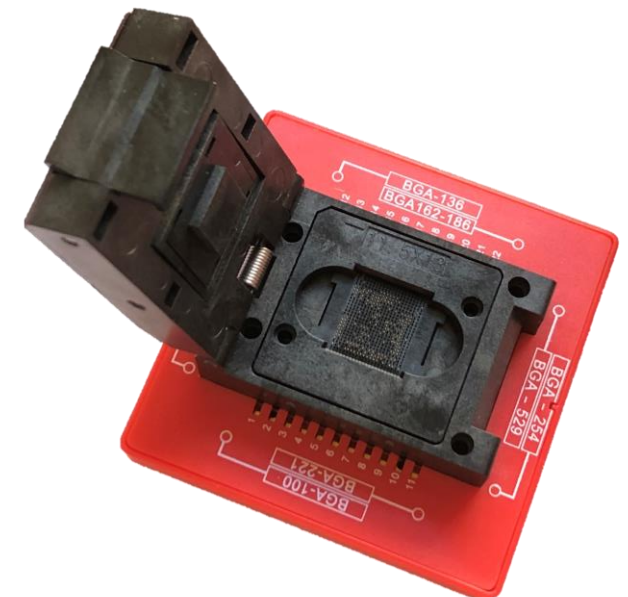
eMMC chip-off

- Hot air to remove the eMMC from the board
- “eMMC reballing jig” and solder paste
- eMMC adapter

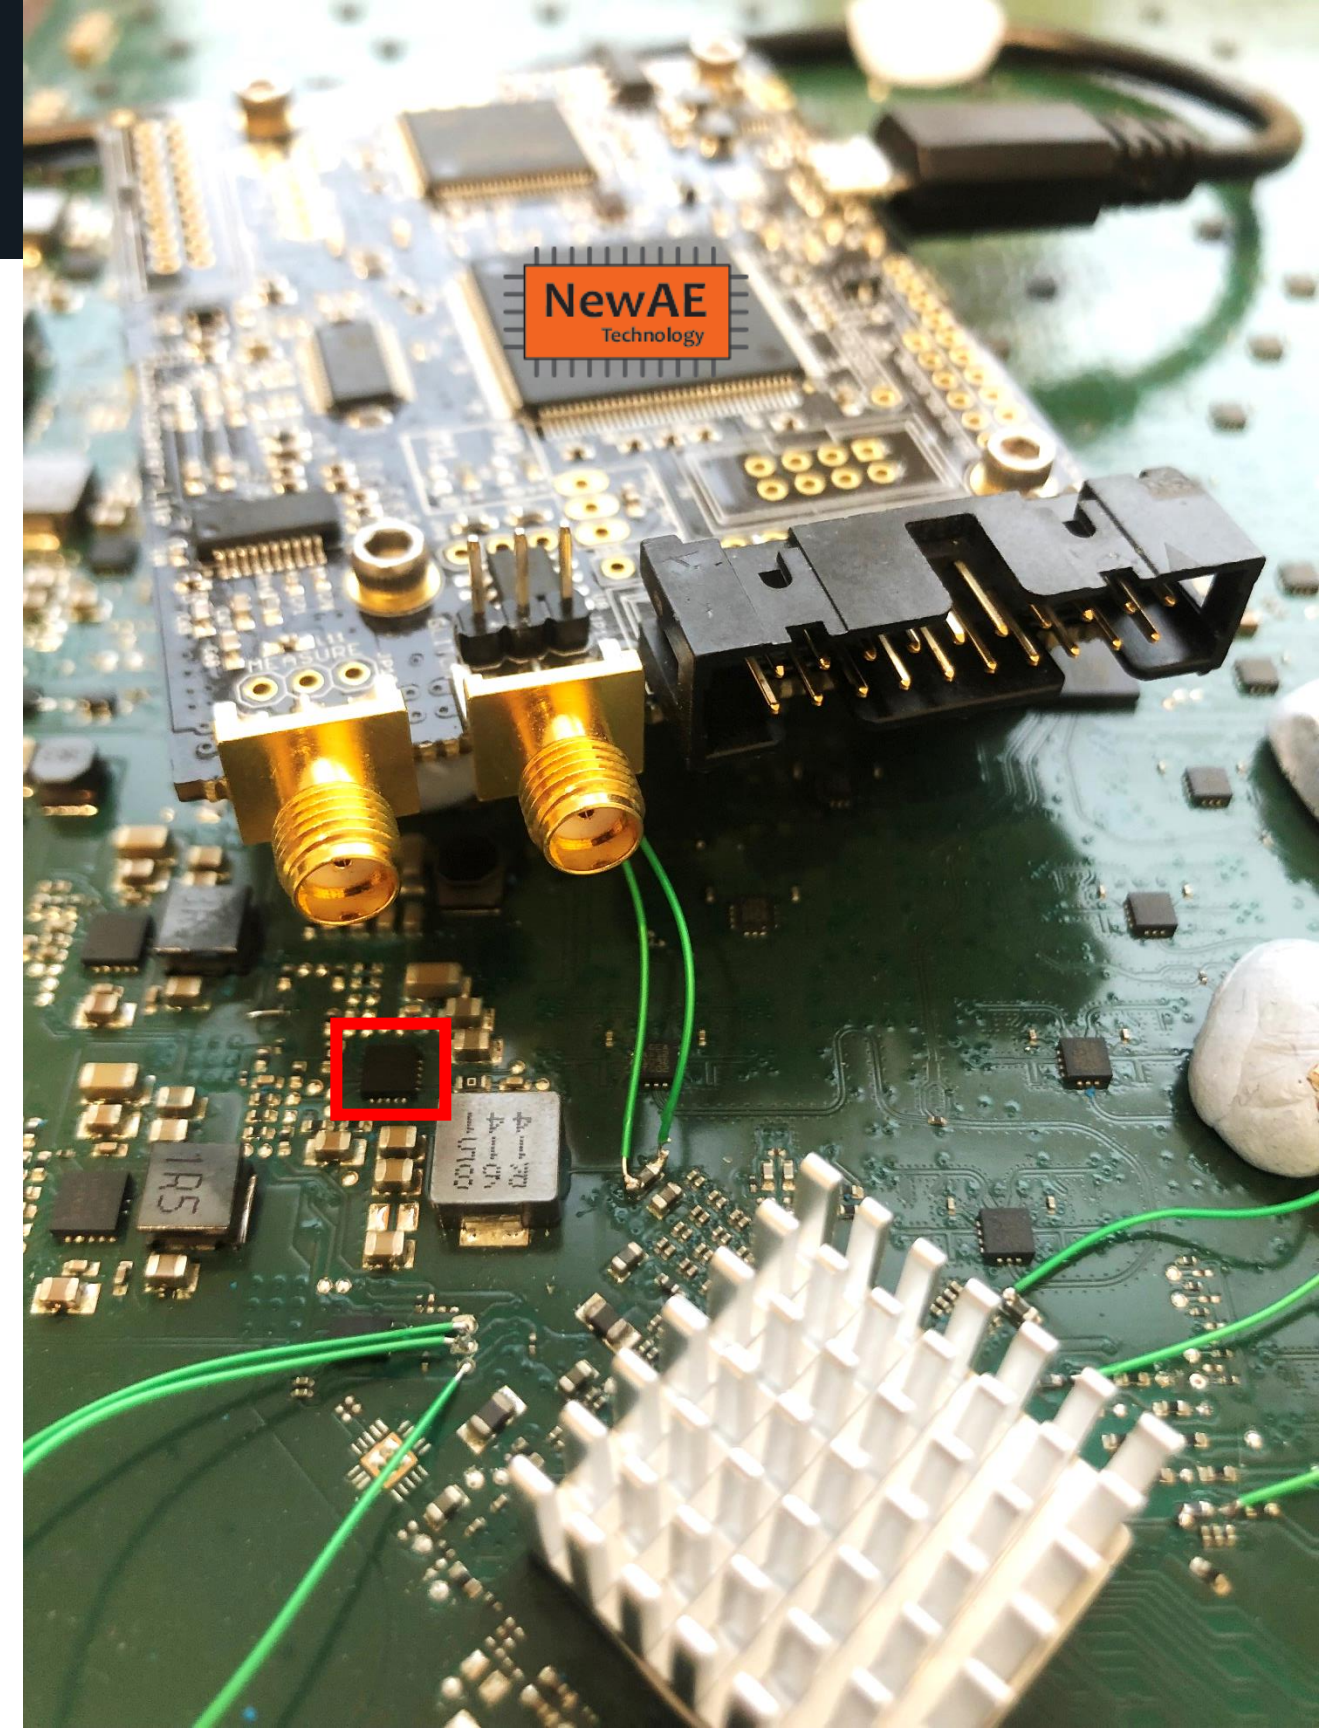
Crowbar VFI

- NewAE ChipWhisperer-Lite (~ \$250)
 - Glitch port is connected to the SoC core voltage
 - Momentarily shorts core voltage to GND
- Core voltage: ~1V, generated by TI TPS56C230
- All decoupling capacitors untouched at this point!
- Oscilloscope triggers on serial data
 - Trigger output is input to the ChipWhisperer-Lite
- Glitch parameters controlled from Python
 - Offset from trigger point
 - Glitch width

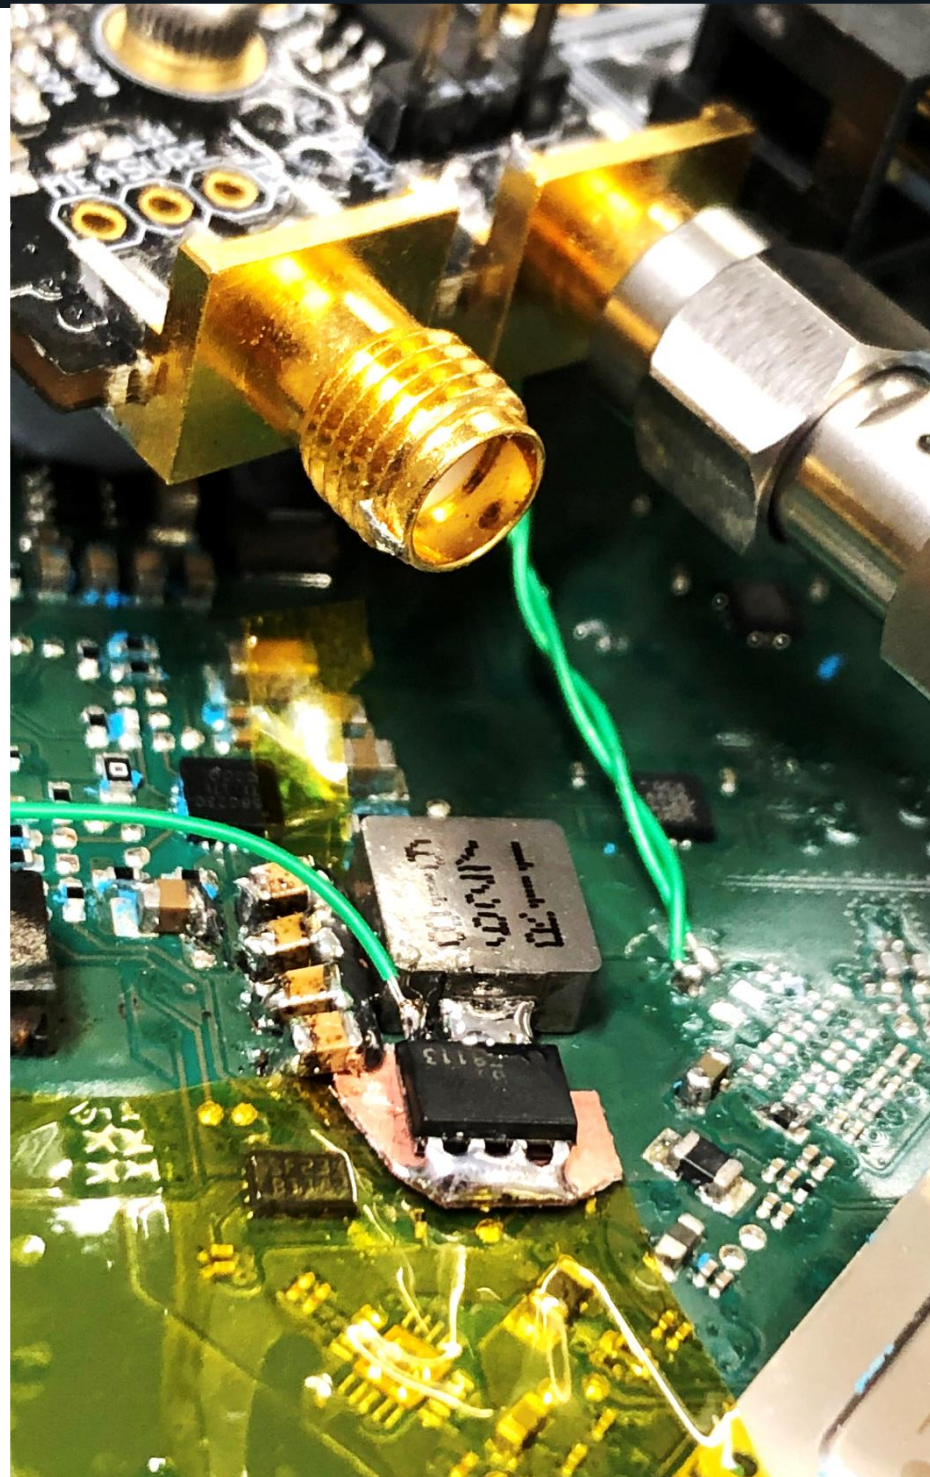
Enabling decoupling capacitors

- Decoupling capacitors are needed for later boot stages
- Experimented with:
 - N-channel MOSFETS
 - P-channel MOSFETS
 - High/Low side switching
 - Gate voltage
 - MOSFET drivers
 - Capacitor sizes
 - Timing

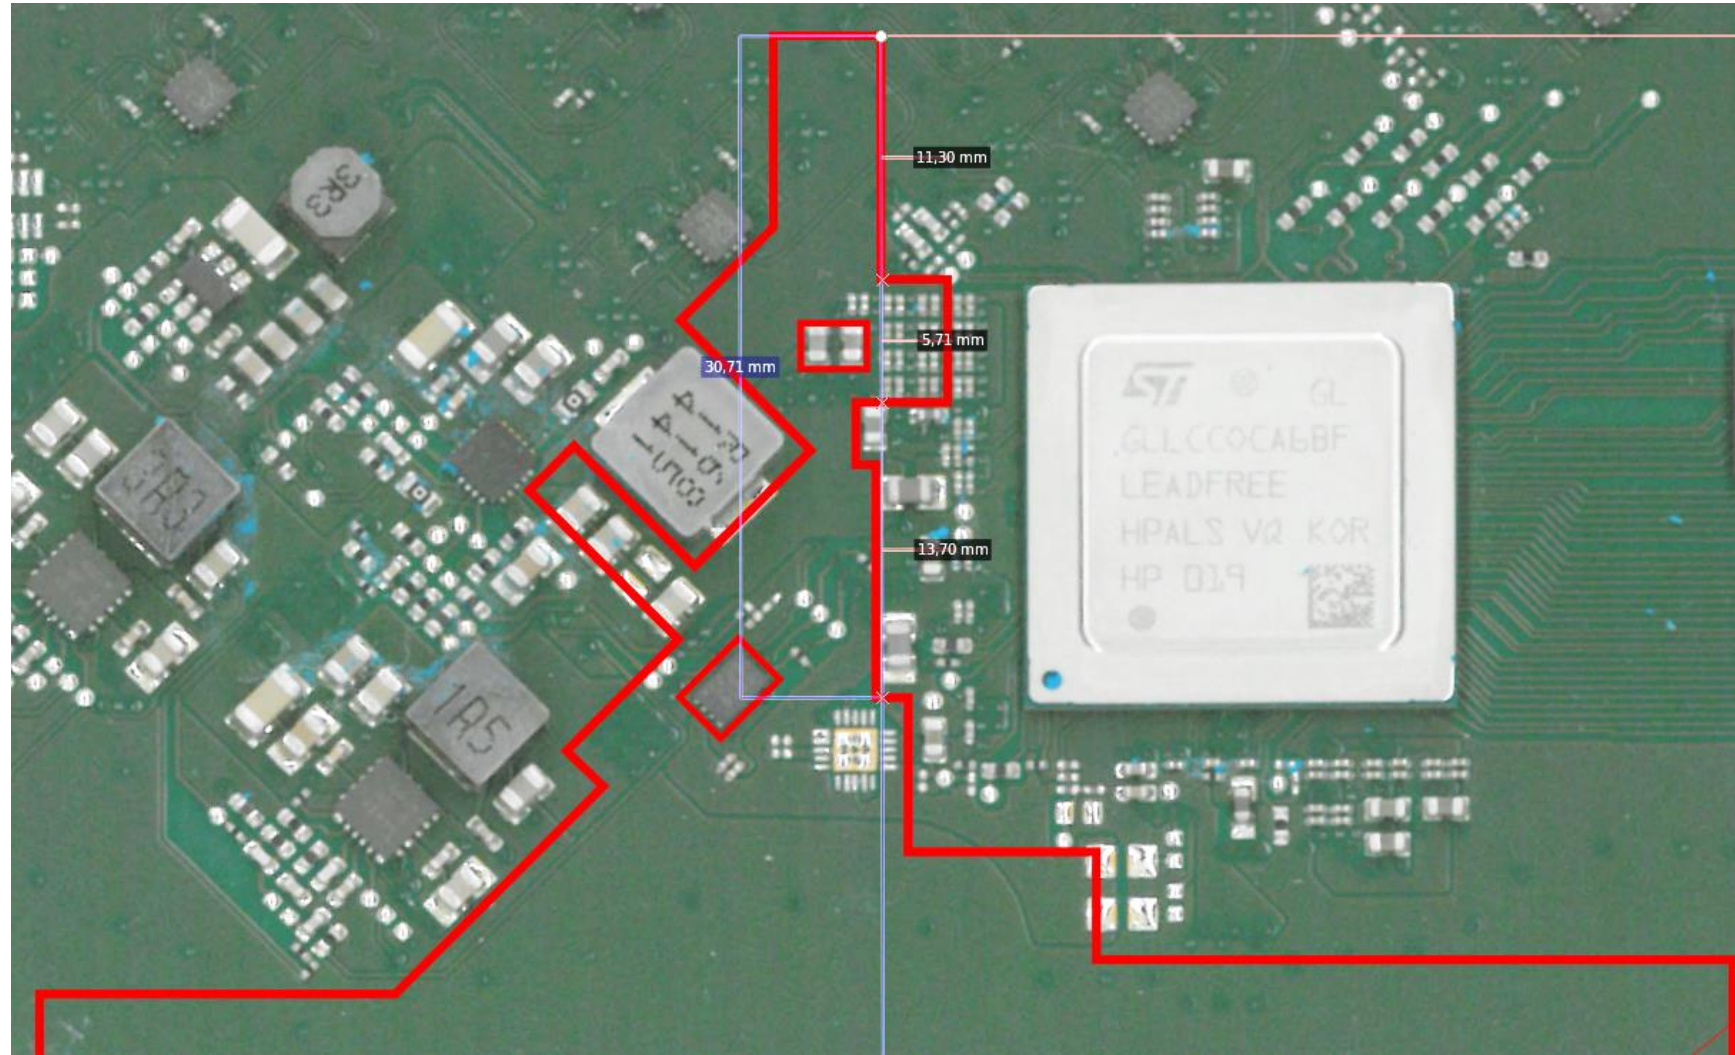
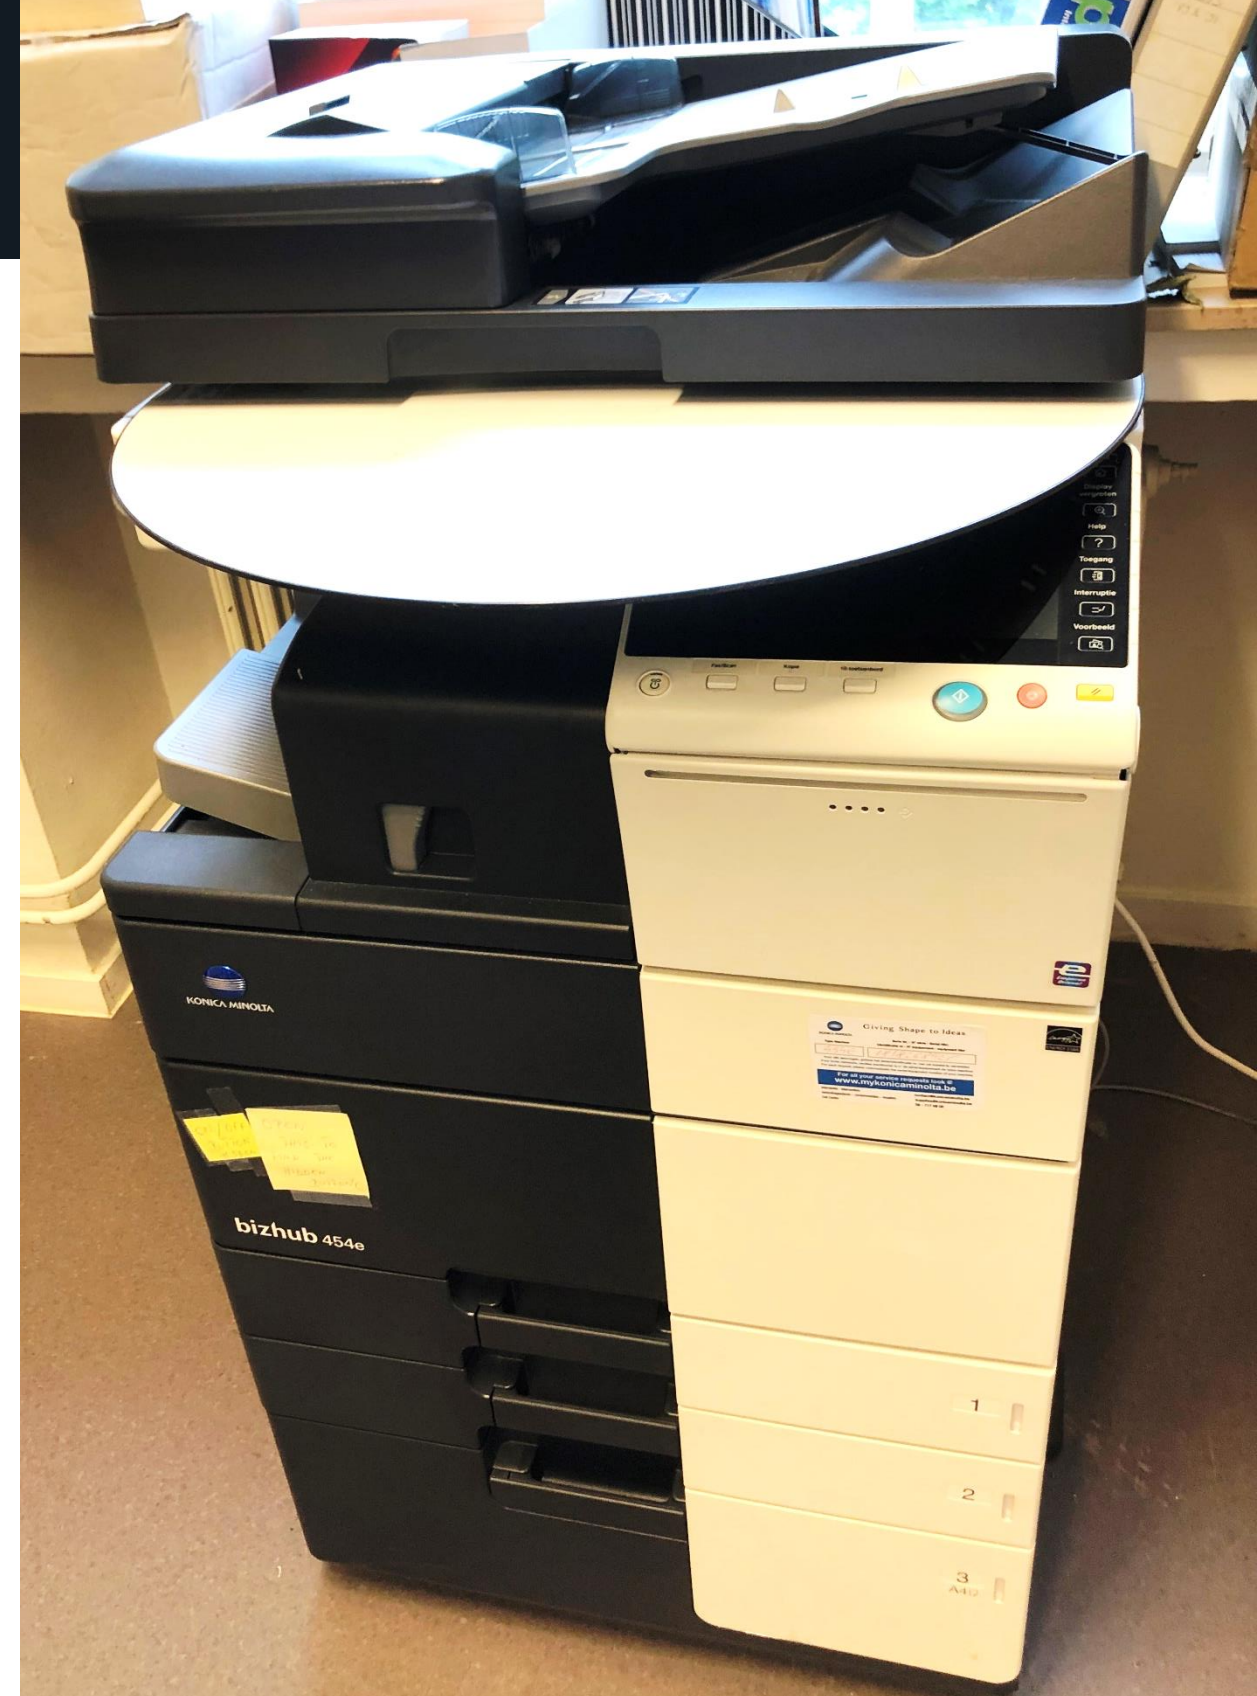
PCB design

- Scanner @ 600 DPI
- Draw board outline at real size in Inkscape
 - Load in KiCad and use in the edgecuts layer
