Glitched on Earth by Humans: A Black-Box Security Evaluation of the SpaceX Starlink User Terminal

Lennert Wouters

COSIC

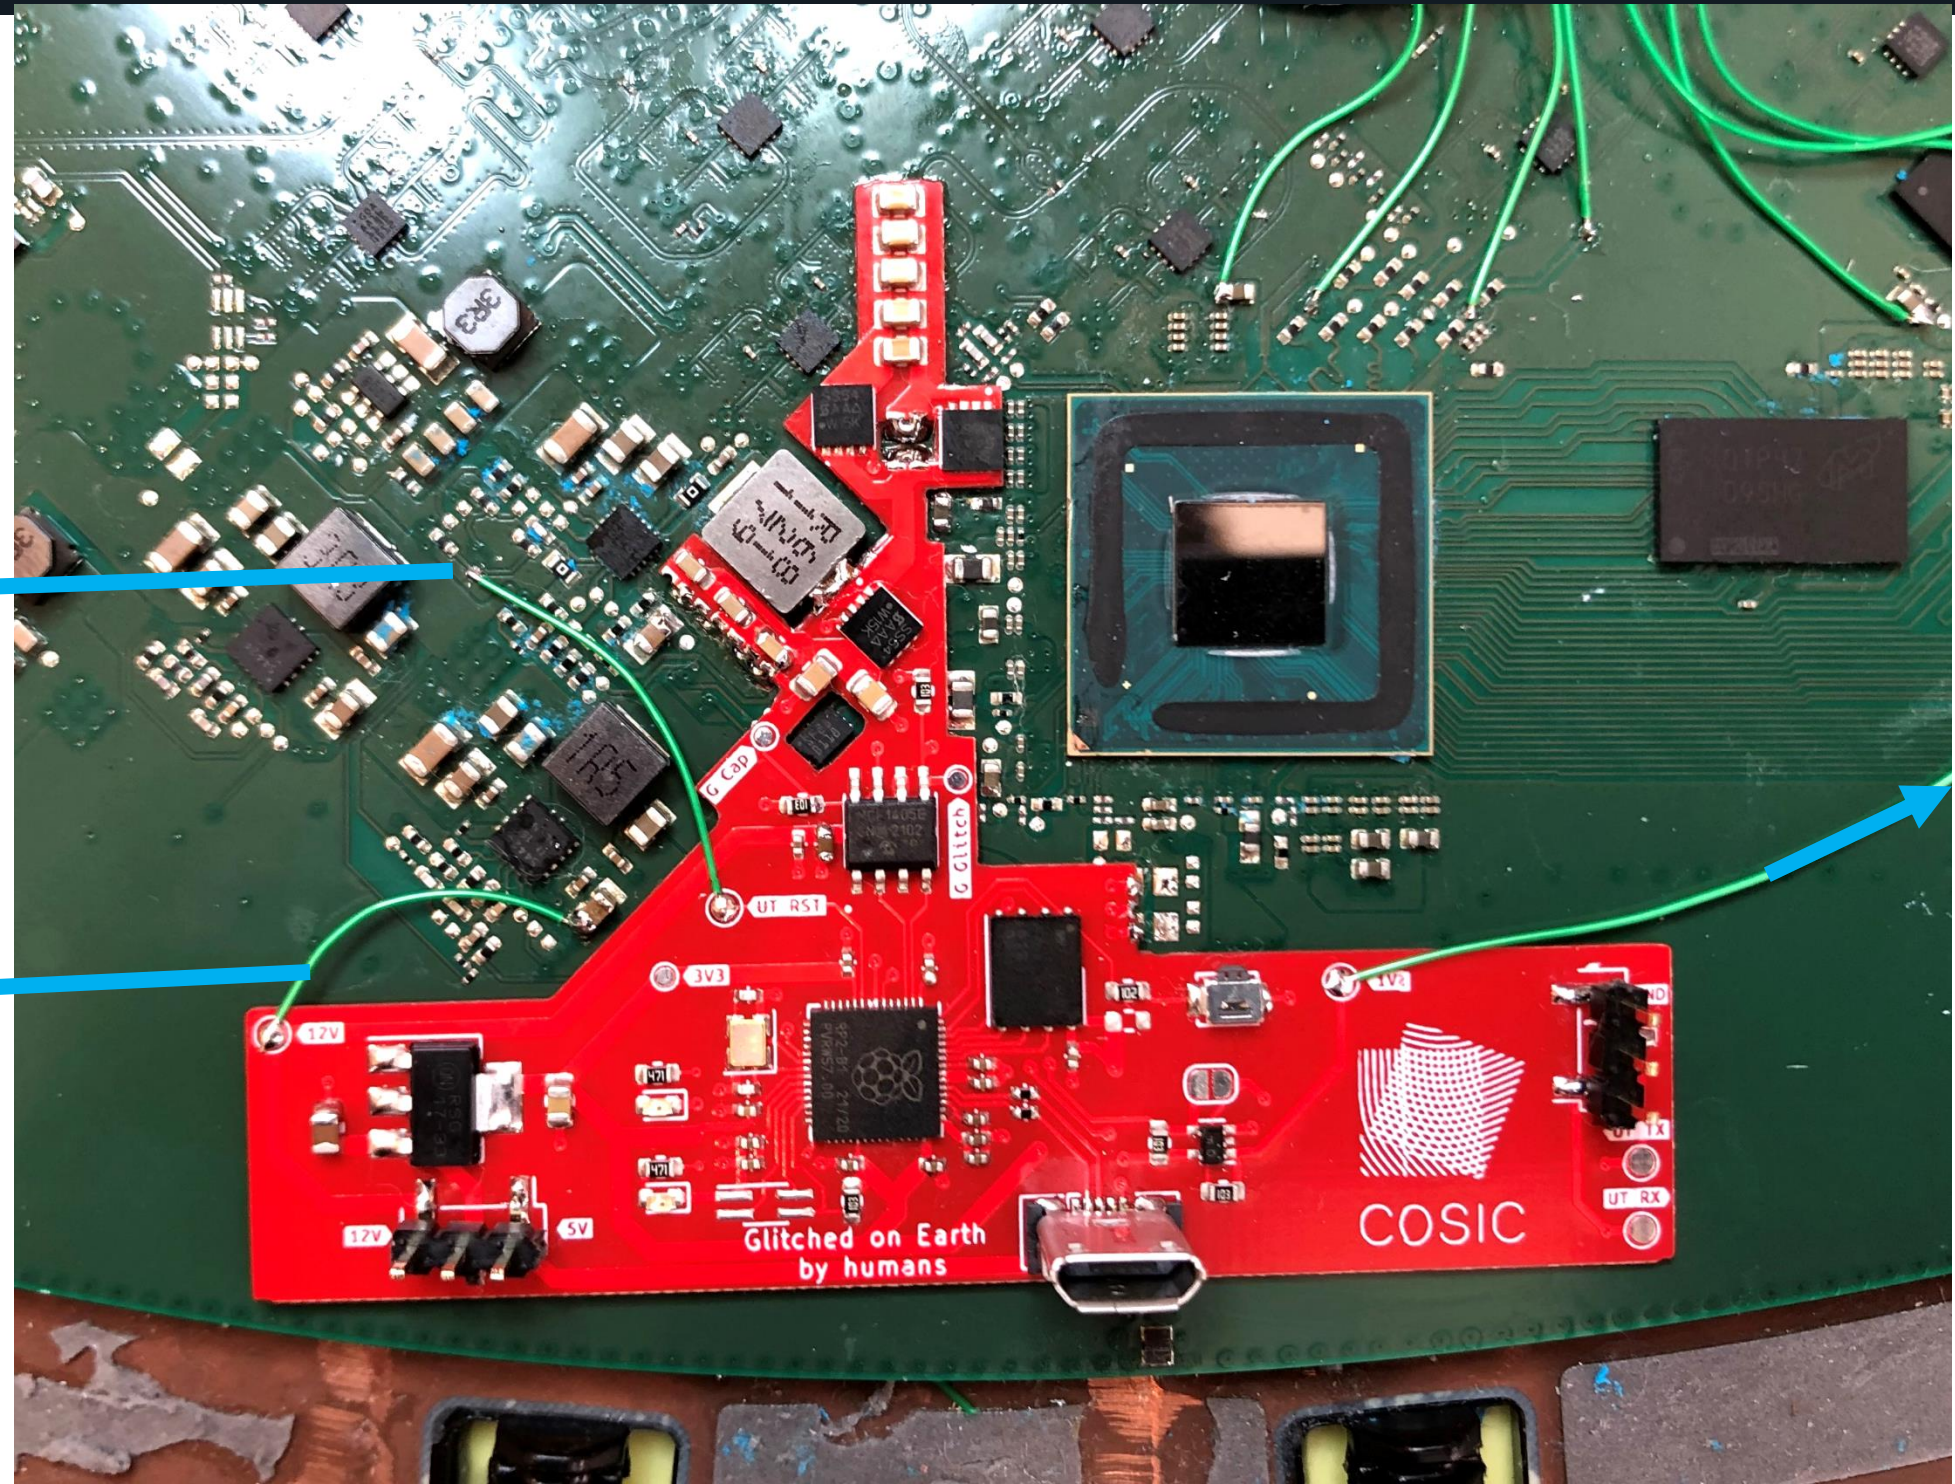
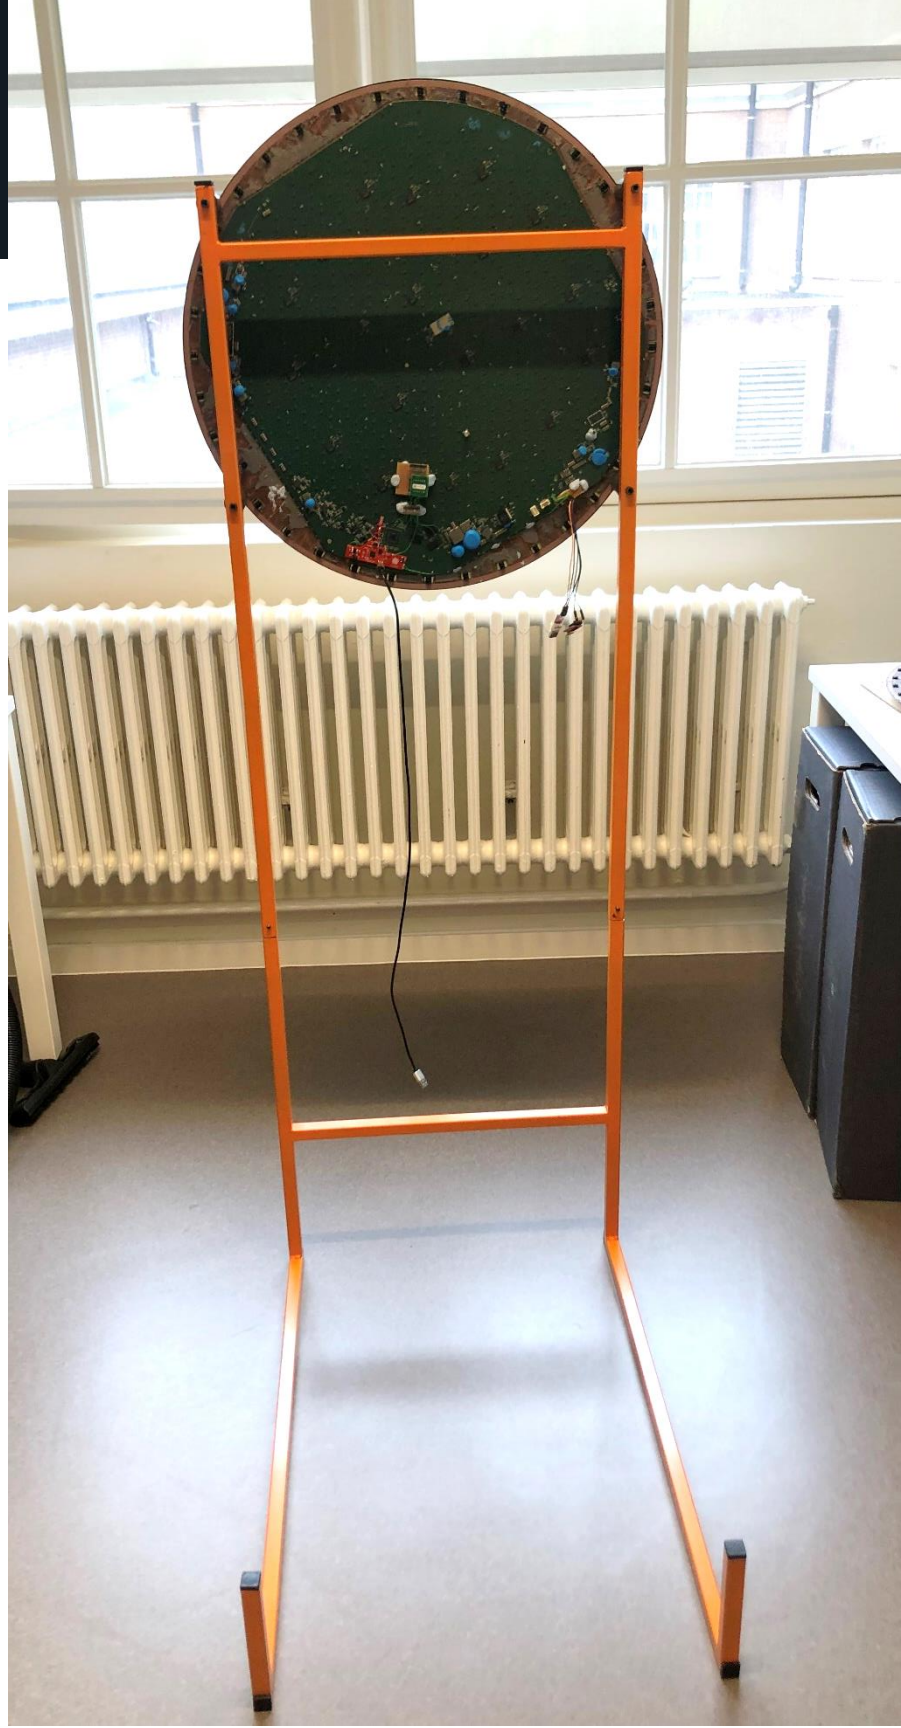
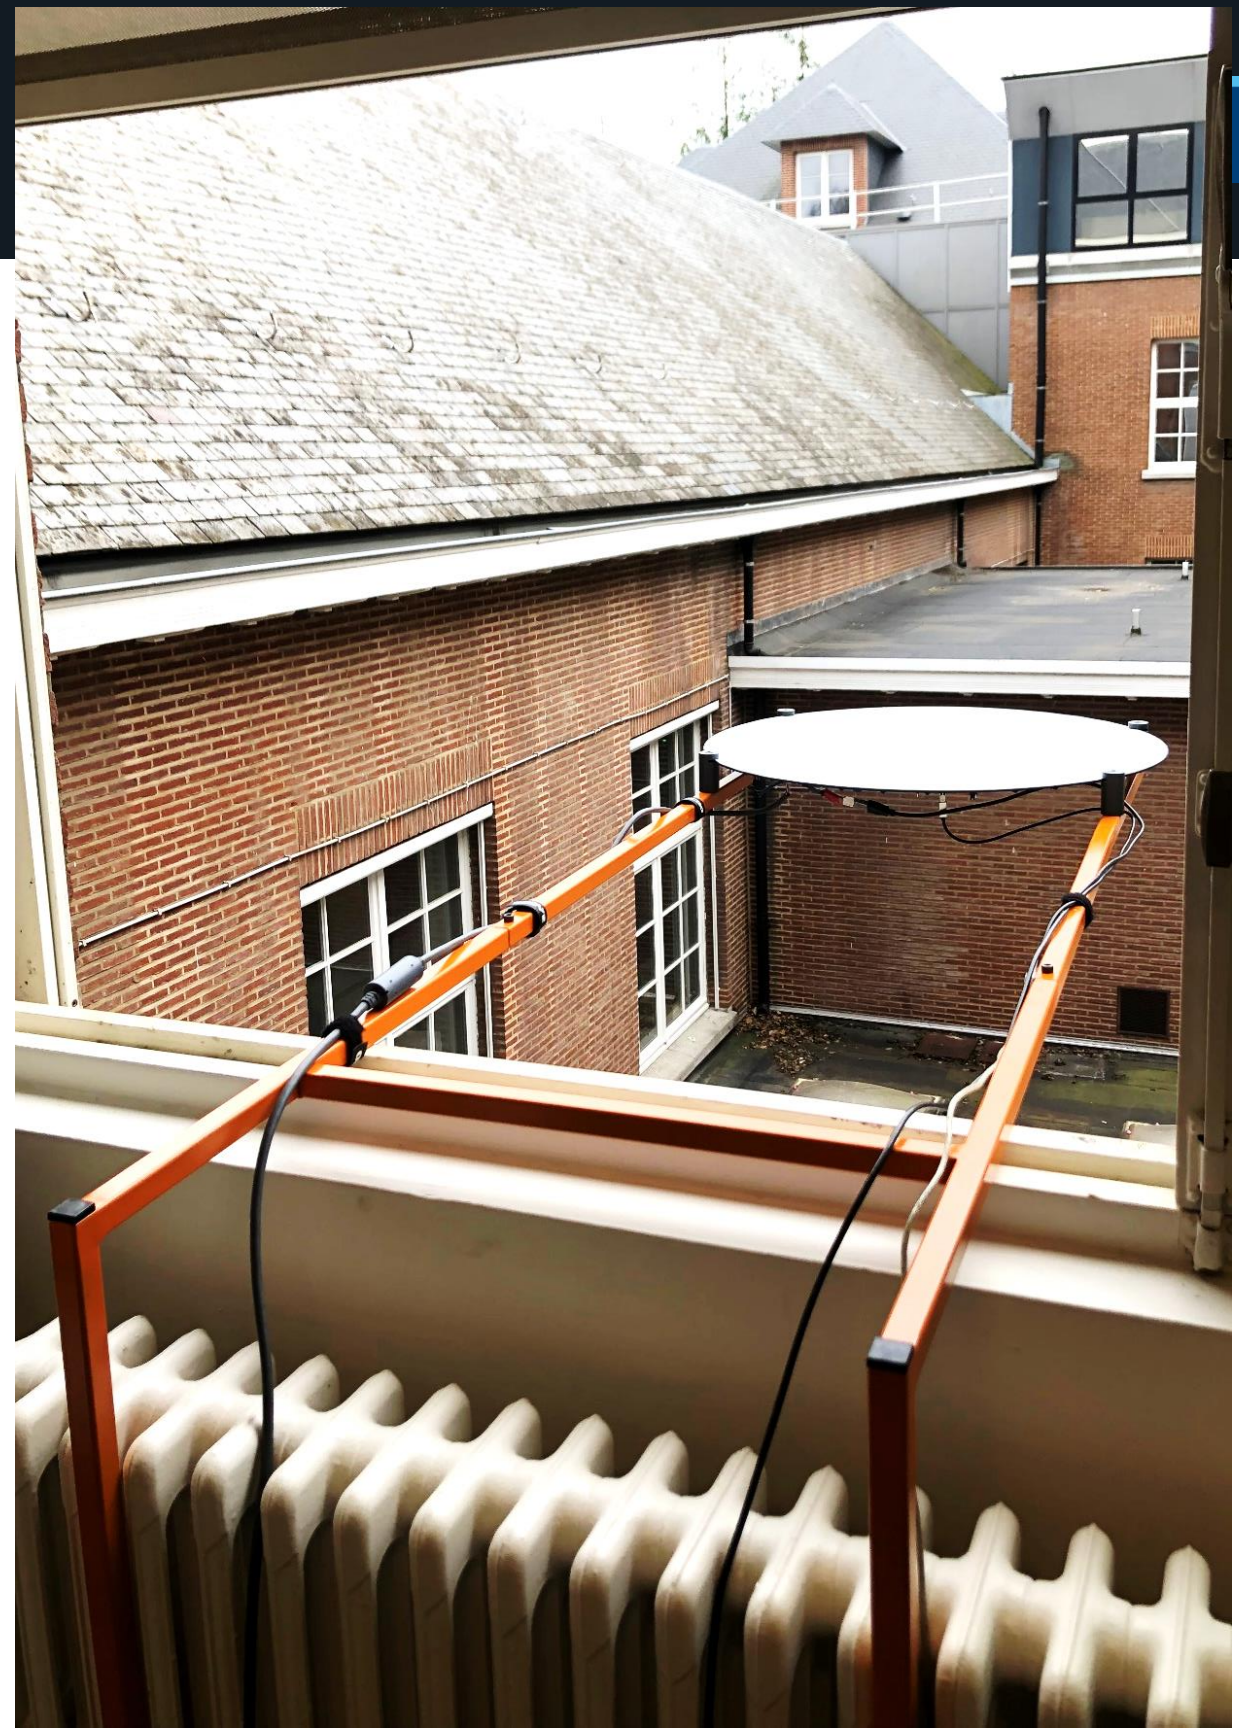
Installed modchip

Core voltage regulator
enable pin
(for power cycling)

12V for MOSFET drivers
and standalone power

1V8 for
level shifter

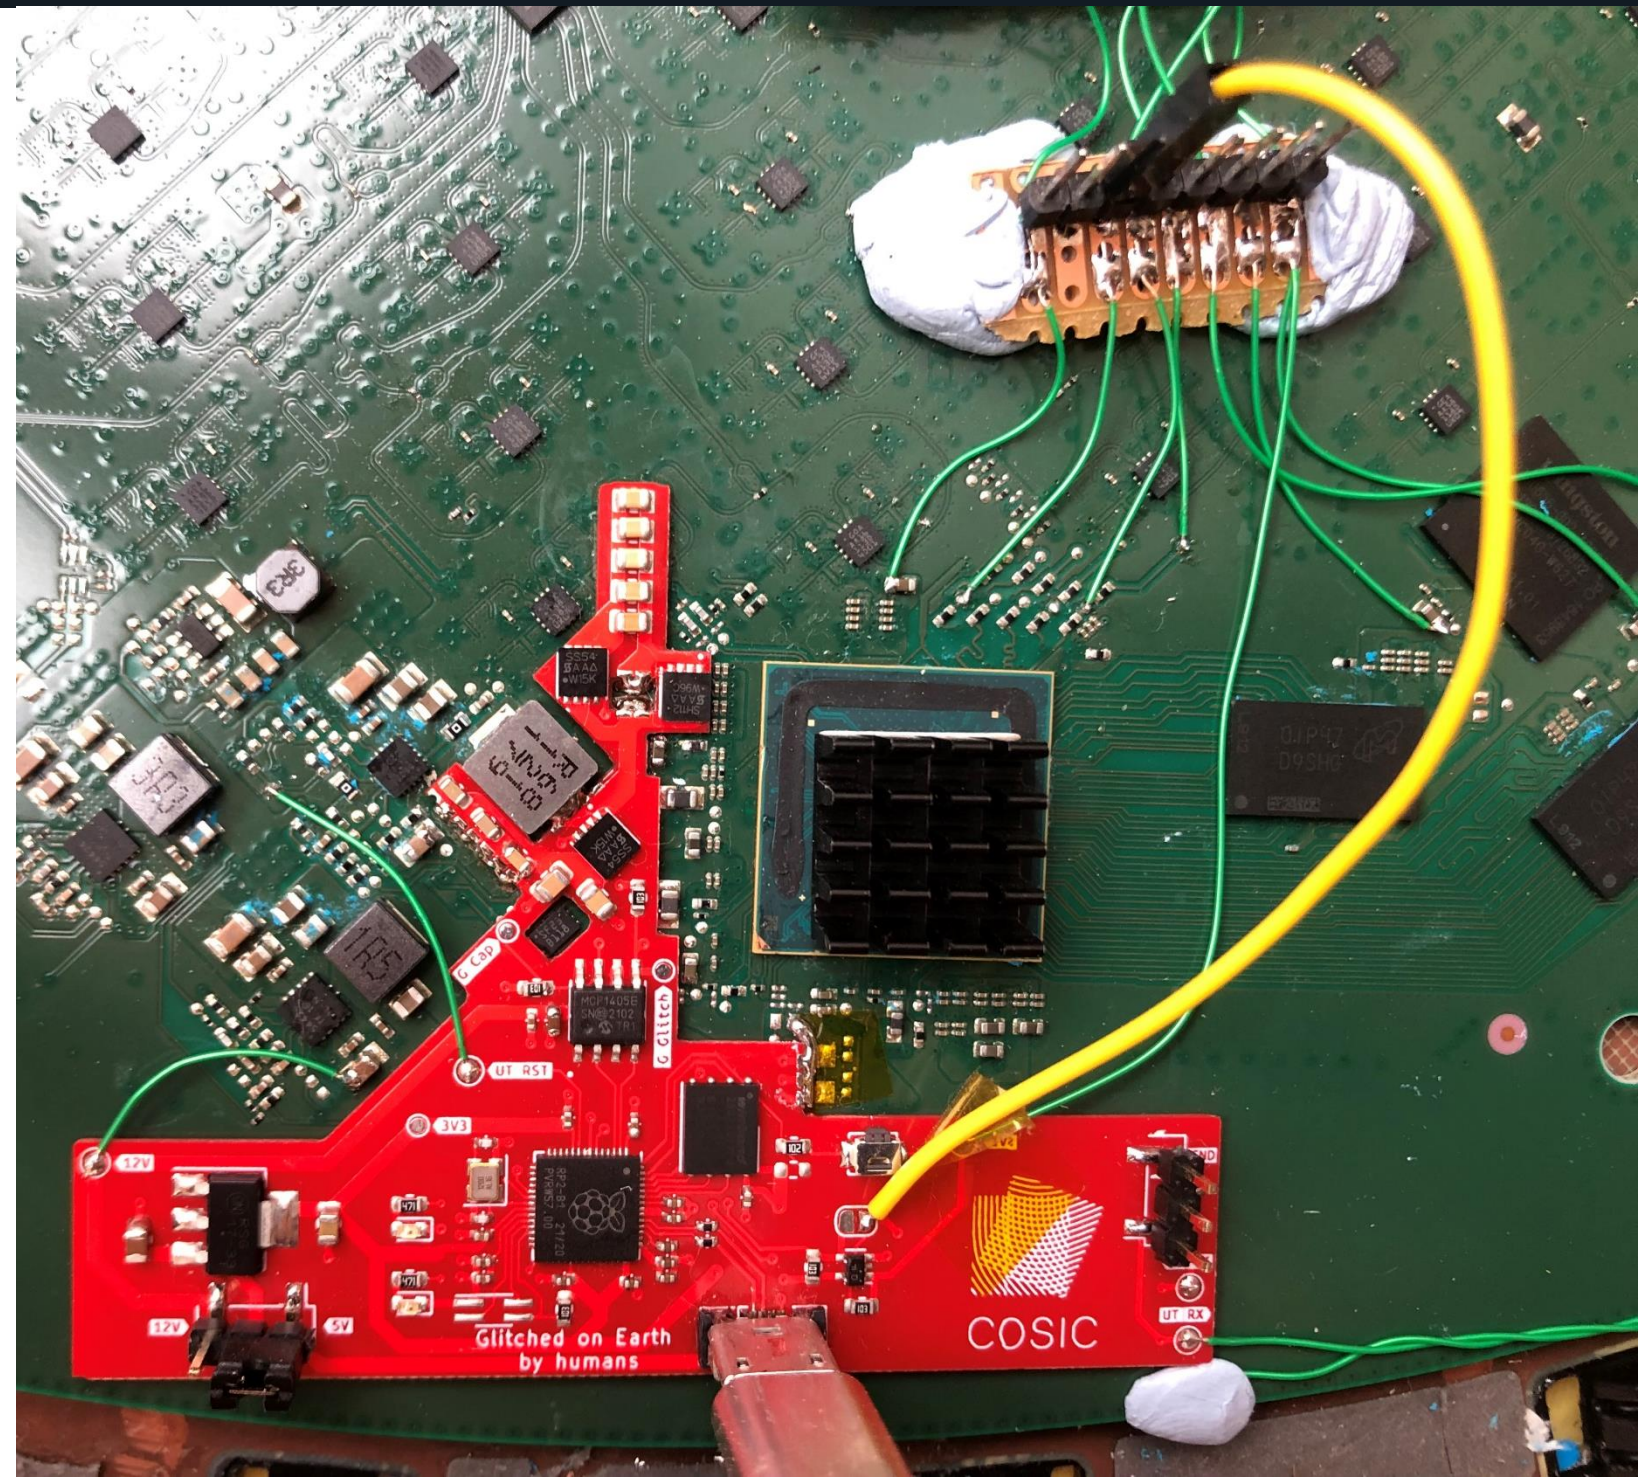
Overcome

- Trigger on eMMC D0 instead of UART
- Modchip could be easily adapted
 - Disconnect UT UART TX
 - Connect to eMMC D0
 - Update glitch parameters from Python
- Alternative: new PCB revision
